# Technical Service Bulletin

Model	GETZ(TB)
Group	ENGINE ELECTRICAL(27)
Number	5-27-P11-TB
Date	Mar. 16, 2005
Area	Europe

**Subject**  
**ECM REPROGRAMMING INSTRUCTIONS FOR EXCESSIVE FUEL CONSUMPTION(F/FIX)**

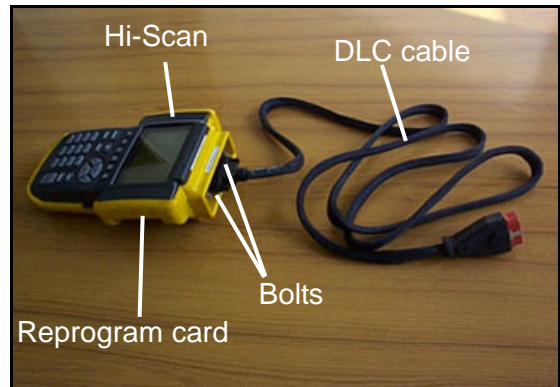
DCP03217

- 1) Attach the Data Link Connector (DLC) cable to the Hi-Scan Pro main body and securely tighten the two bolts.
- 2) Remove the system software card from the Hi-Scan Pro and insert the reprogramming software card, with the new ECM program, into the Hi-Scan top slot. The only card in the Hi-Scan should be the reprogramming card.

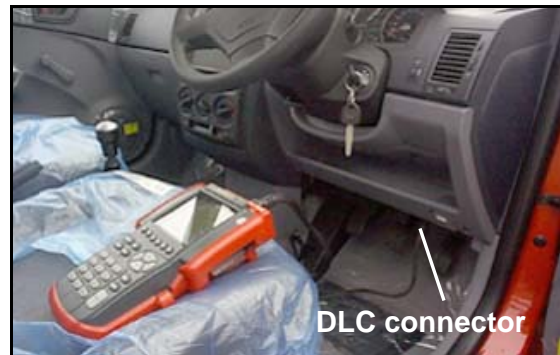
DCP09950

- 3) Plug the DLC cable from the Hi-Scan Pro into the data link connector (16 Pin connector) under the instrument panel on the driver's side.

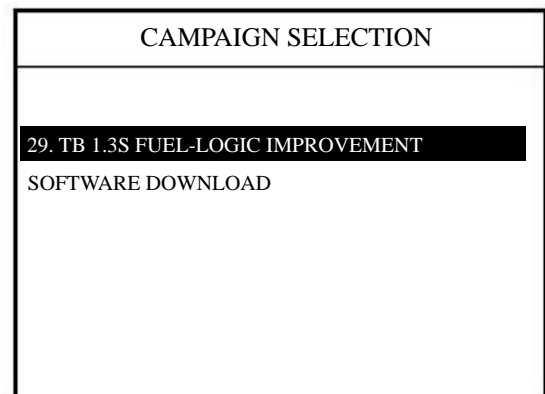
- 4) Turn the ignition switch to the ON position (Do not start the engine).
- 5) Turn the Hi-Scan Pro ON and press ENTER.
- 6) Select option "30. TB 1.3S FUEL-LOGIC IMPROVEMENT" and press ENTER.

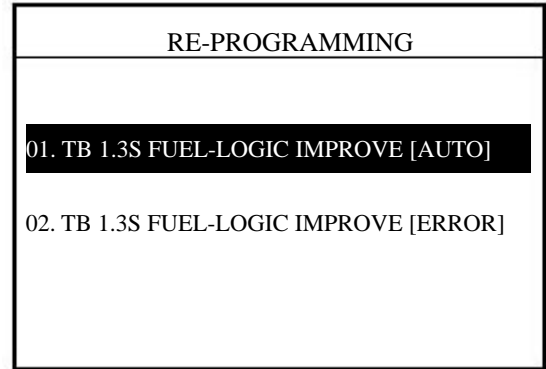
7) Select option “01. TB1.3S FUEL-LOGIC IMPROVE [AUTO]” and press ENTER.

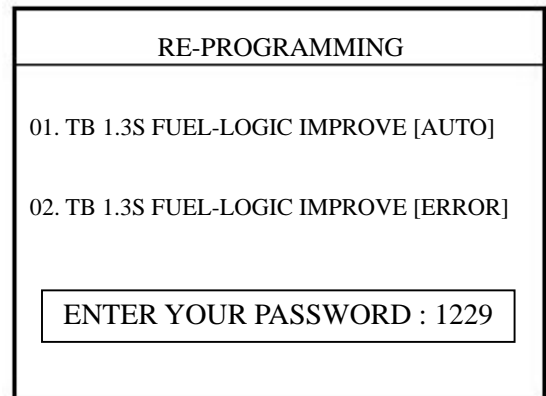
8) Enter “1229” as the password for automatic reprogramming mode and press ENTER.

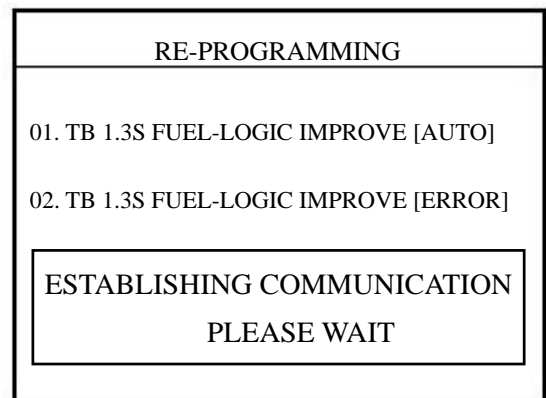
9) The Hi-Scan Pro will establish communication, check the ECM ID, and reprogram the ECM automatically. Wait until the reprogramming is finished.

- The Hi-Scan Pro detects the current ECM ID, assigns the new ECM ID and displays them on the Hi-Scan Pro screen.
- Check the ECM IDs displayed on the Hi-Scan Pro screen to verify that the correct ECM software is being downloaded.  
Refer to the “ECM SPECIFICATION TABLE” on page 4 of this TSB.
- If the Hi-Scan Pro does not download the program, use the Manual Update Procedure following this section.

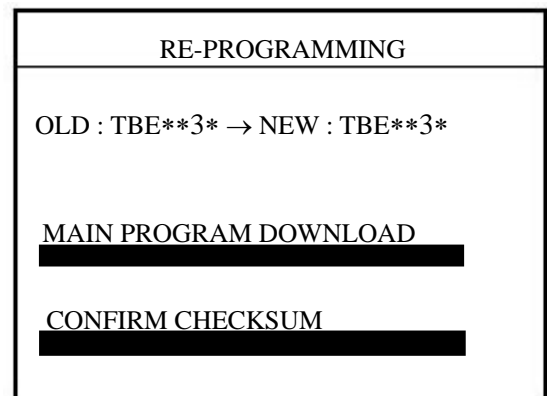
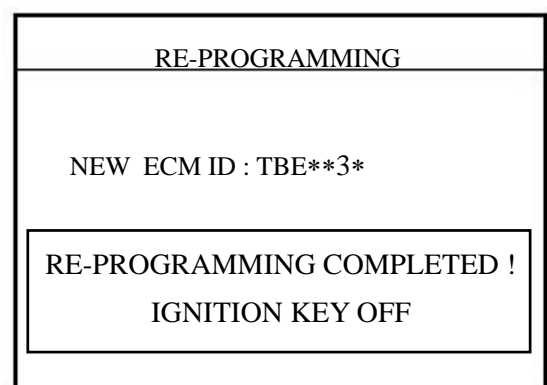
10) When the “COMPLETED” message is displayed, turn the Hi-Scan Pro OFF and the process is complete.

11) When the reprogramming is completed successfully, turn the ignition to the OFF position for 20 seconds and then start the engine to check for proper operation.

12) Check for diagnostic trouble codes using the Hi-Scan Pro with system software card. Erase any trouble codes.
